STATE OF CALIFORNIA
 DEPARTMENT OF CALIFORNIA HIGHWAY PATROL
MULTIDISCIPLINARY ACCIDENT INVESTIGATION TEAM NARRATIVE/DIAGRAM
 CHP 558D (Rev. 9-08) OPI 065 (MAIT use only)

DATE OF CRASH (MONTH-DAY-YEAR)	TIME (2400)	NCIC	OFFICER ID	AREA/AGENCY CASE NUMBER	MAIT CASE NUMBER	PAGE
05-04-2022	1132	9501	16129	C22-501-003	SS-035-22	10

Physical Evidence Description (continued)

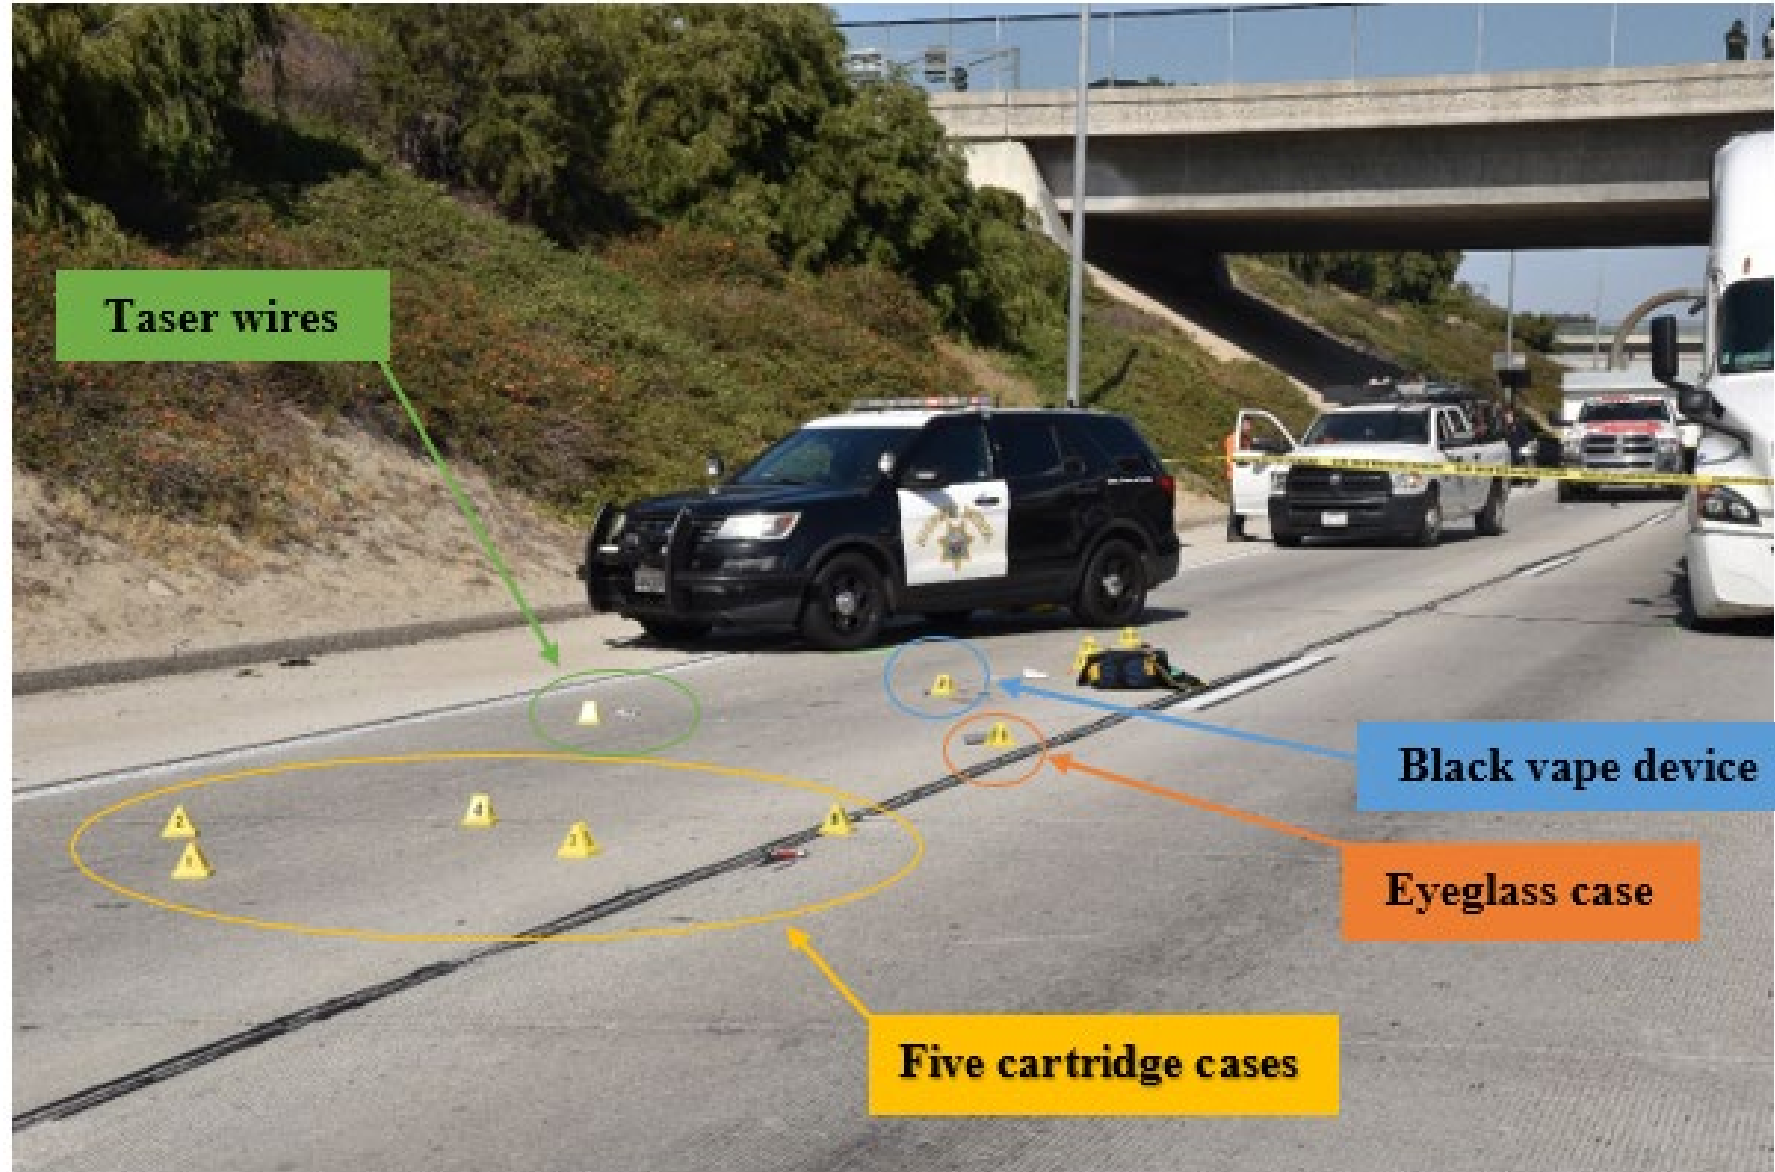
Image 3: Scene photo of evidentiary items recovered from the sixth lane of the interstate to the west of Van Dragt's patrol vehicle.
